BUILDING SCIENCE SERIES

Natural Weathering of Mineral Stabilized Asphalt Coatings On Organic Felt

Natural Weathering of Mineral Stabilized Asphalt Coatings on Organic Felt

Sidney H. Greenfeld

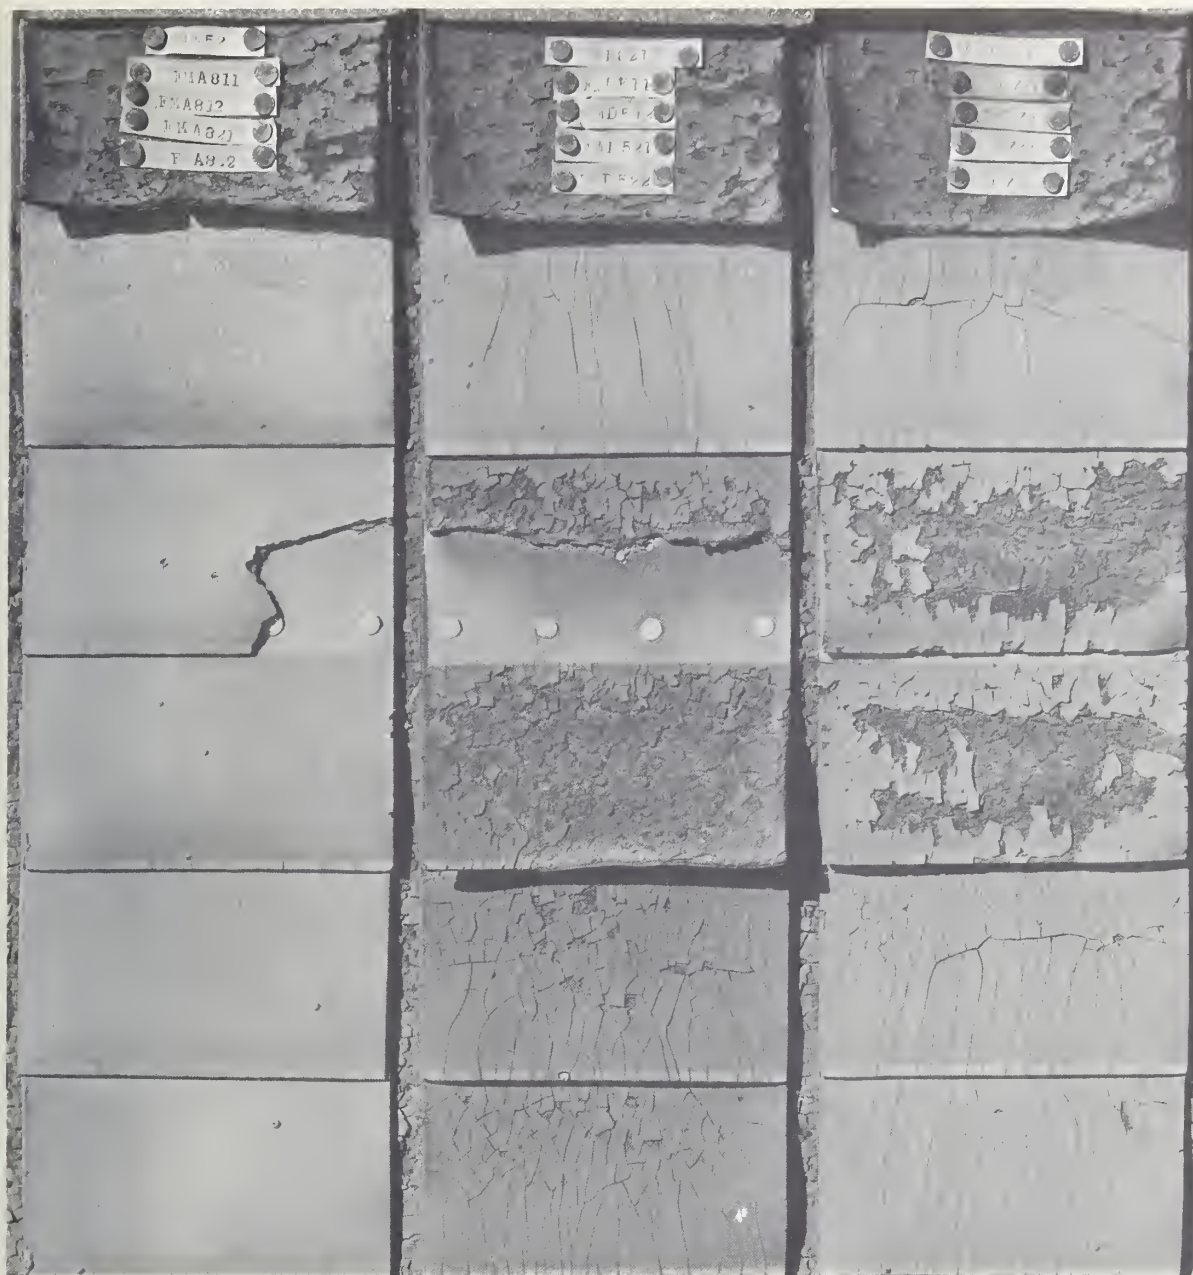
FIGURE 3. Smooth-surface, felt-base specimens after 16½ years of exposure ¹

¹ Mid-Continent Asphalt.

² Tabs partially torn off.

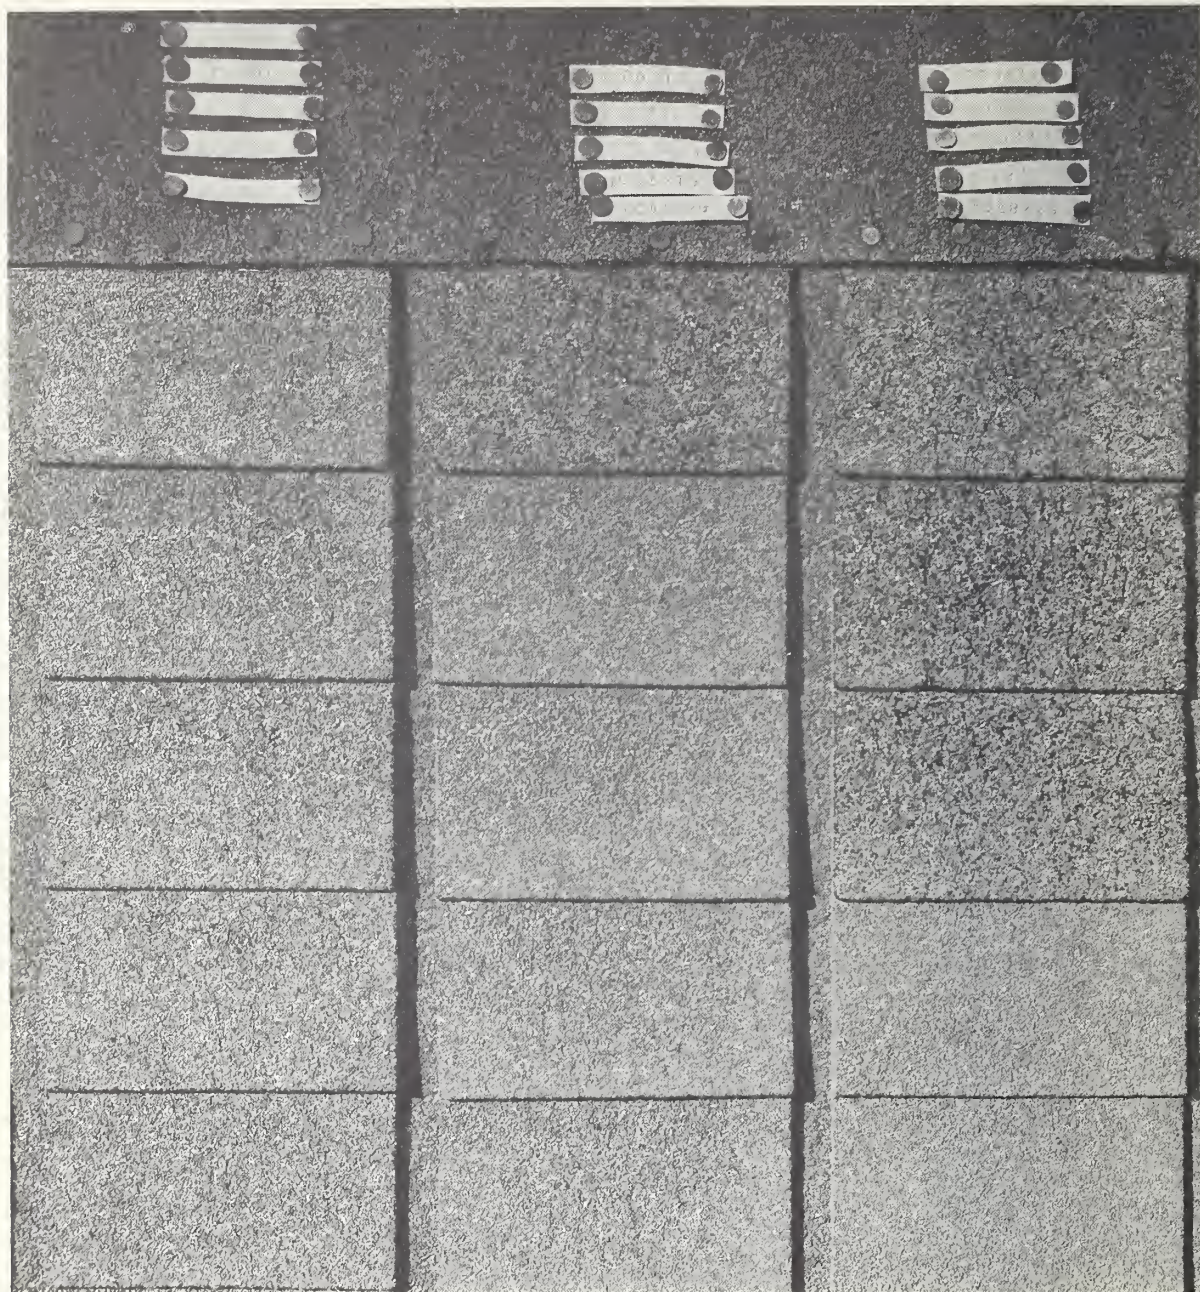
FIGURE 4. Granule-surfaced, felt-base Venezuela specimens after 15 years of exposure
(Initial granule coverage approximately 25 lb/100 sq ft (1.22 kg/m²))

Figures 4 and 5 are photographs of California and Venezuela specimens after 15 years of exposure. The unstabilized asphalt coatings show noticeable losses of granules and cracking of the coatings. Cracking of the coatings is also evident in the California coatings containing clay. However, all of the granule-surfaced specimens are still performing well after 15 years and should give many more years of protection from the weather.
